Manhole Inspection Summary

Manhole # S35I__026MH

Insp Date: 11/19/08 2:57 PM

Location Address: **100 s charles st**

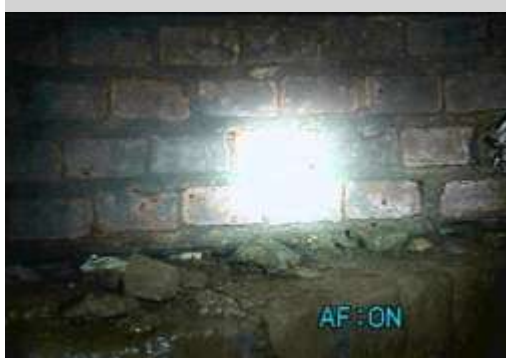
Misc

bench debris

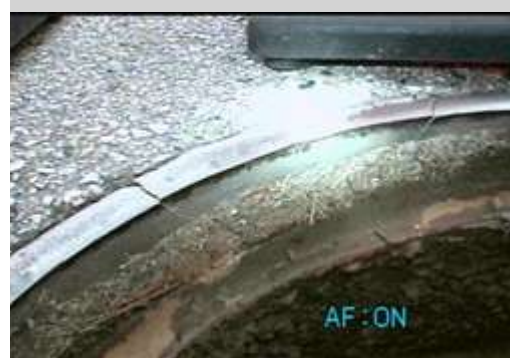
Defect 7

cracked frame

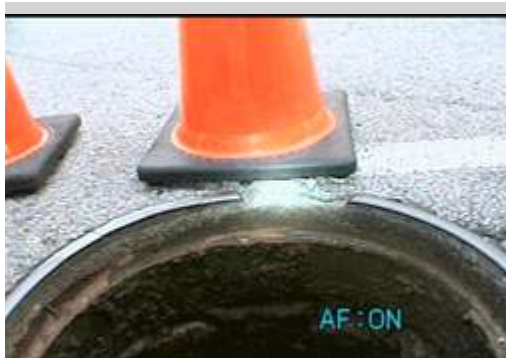
Defect 6

chipped frame

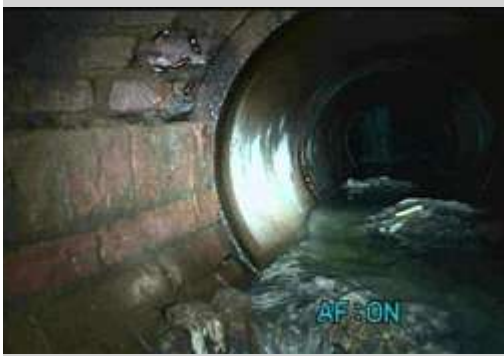
Defect 4

channel debris

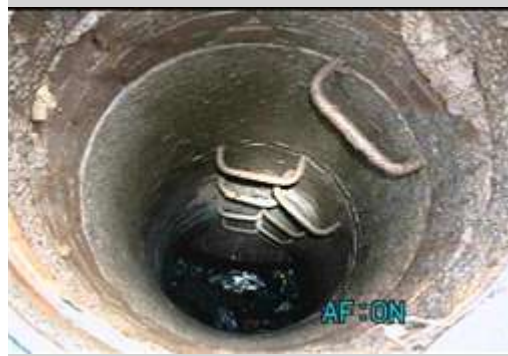
Defect 2

deteriorated chimney, corr steps, corbel infiltration

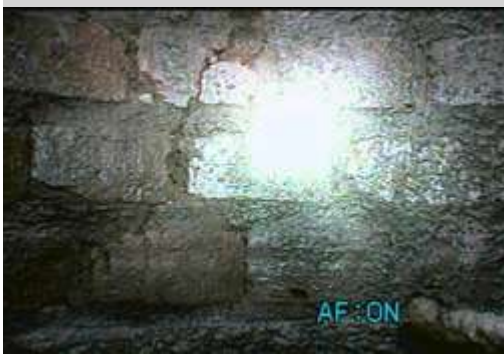
Defect 1

cracked chimney, infiltration, frame adj

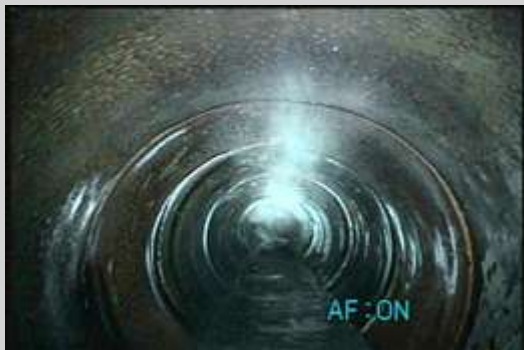
12 O'Clock Outflow

21 in. Circular Gravity Sewer
Pipe Out @ 12 O'Clock

Pipe Material: **Clay** ☐ Pipe Lined

Invert Depth: 17.33 (ft.) Flow Characteristics: **Fast**

Infiltration: **None** Pipe Seal Cond: **Unknown**

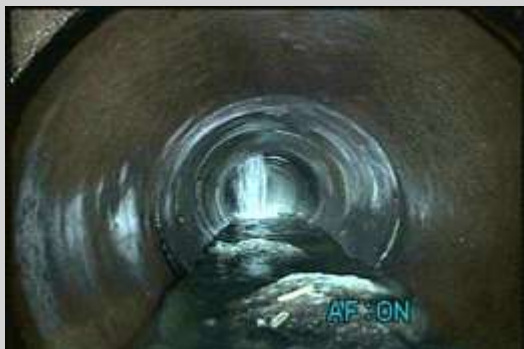
5 O'Clock Inflow

21 in. Circular Gravity Sewer
Pipe In @ 5 O'Clock

Pipe Material: **Clay** ☐ Pipe Lined

Invert Depth: 17.00 (ft.) Flow Characteristics: **Fast**

Infiltration: **None** Pipe Seal Cond: **Unknown**

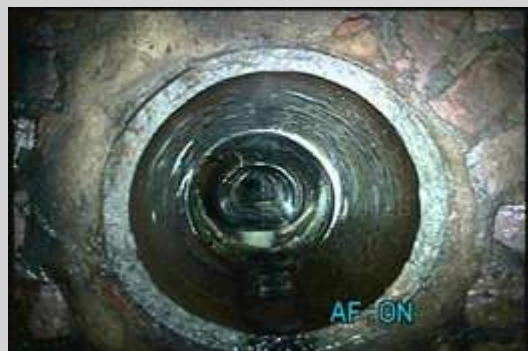
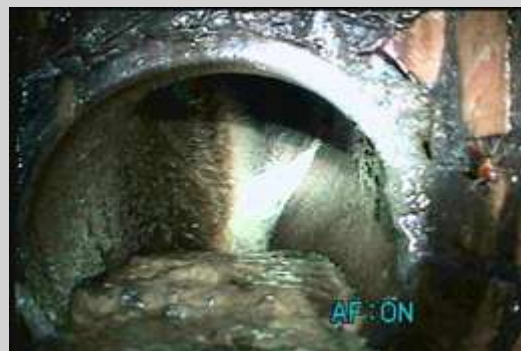
8 O'Clock Inflow

10 in. Circular Gravity Sewer
Pipe In @ 8 OClock

Drop In @ 8 OClock

Drop: **Outside** **Direct**

Drop Condition: **Open**
